Pentium® Pro Processor Specification Update

Release Date: June 1998

The Pentium® Pro processor may contain design defects or errors known as errata which may cause the product to deviate from published specifications. Current characterized errata are documented in this Specification Update.

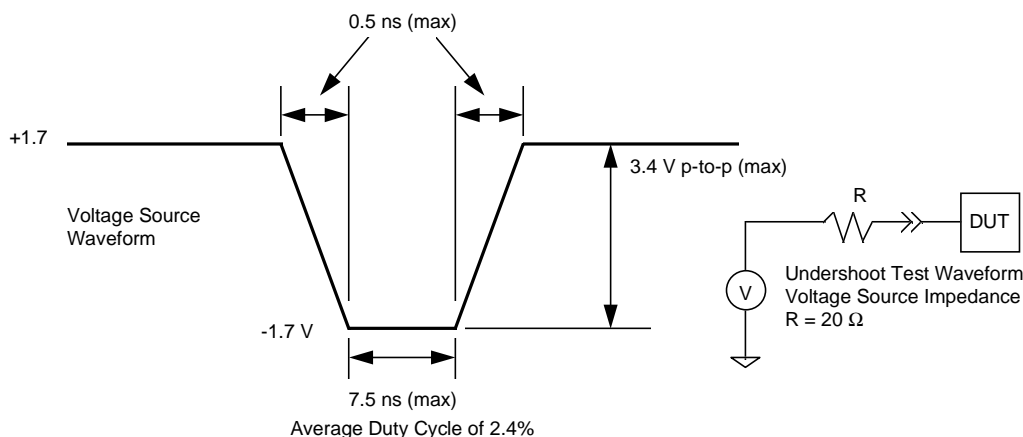
The Pentium Pro processor bus signals AERR#, BERR#, BINIT#, BNR#, HIT#, and HITM# (only) are capable of sinking an 85 mA current pulse at 2.4% average time duty cycle. This is equivalent to -1.7 V applied to a 20Ω source in series with the device pin for 8 ns at 66 MHz with a utilization of 5%.

Note: This test covers the AC operating conditions only.

The *Pentium® Pro Family Developer’s Manual, Volume 1: Specifications*, Section 11.15, will include the following undershoot specification, to simplify signal integrity issues on signals that can be driven by more than one device simultaneously:

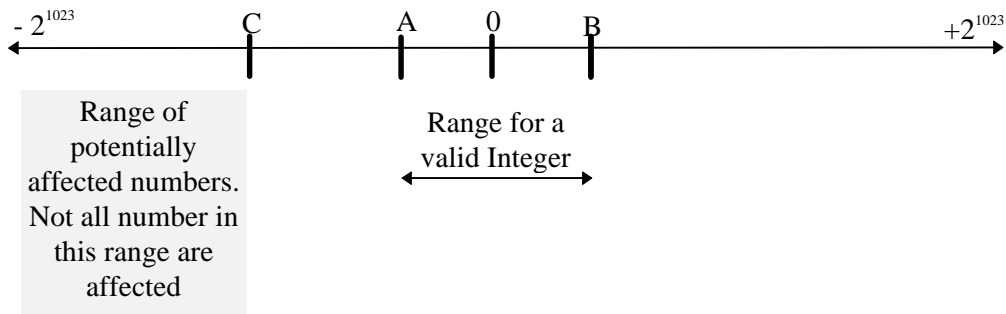
IMPLICATION: Erroneous operation results when the operand is so large that it will not fit into the target data size. The operands affected by this erratum are significantly outside (by a factor of 3X) the range that can be, correctly, converted to an integer value. The figure below and corresponding table identifies the normal range of integer numbers (between A and B) and the starting point of the operands affected by this erratum. Discrete failing operands will be present in the range between point C and the maximum negative number that can be represented by the processor (-2^{1023} in double precision format). Note 2 below gives a qualitative description of the nature of the discrete failing values. Software that does not rely on the Invalid Operation exception flag being set and signaled by either an exception OR by software polling is not impacted by this erratum.

16-bit Operation	A	B	C
	-32,768.0	+32,767.0	< -98304.0
32-bit Operation	A	B	C
	-2,147,483,648.0	+2,147,483,647.0	< -6,442,450,944.0

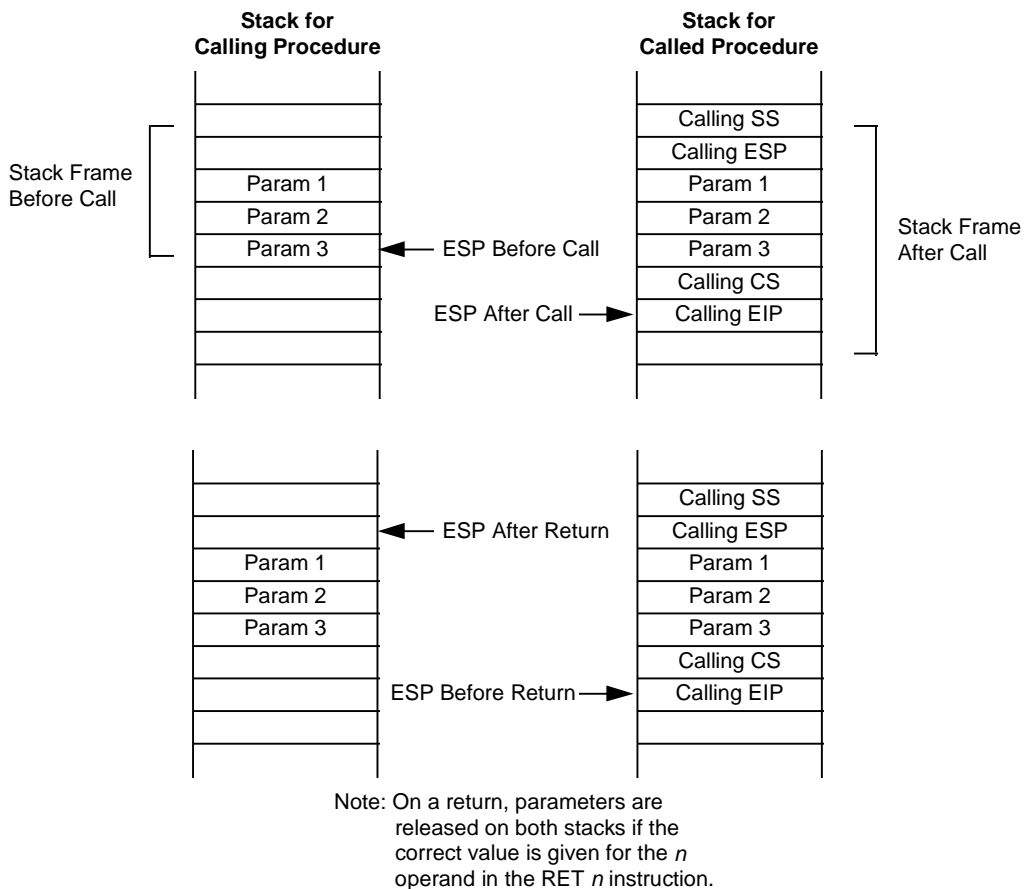
Figure 4-3. Stack Switch on a Call to a Different Privilege Level

When making a call to a more privileged protection level, the processor does the following (see Figure 4-3):

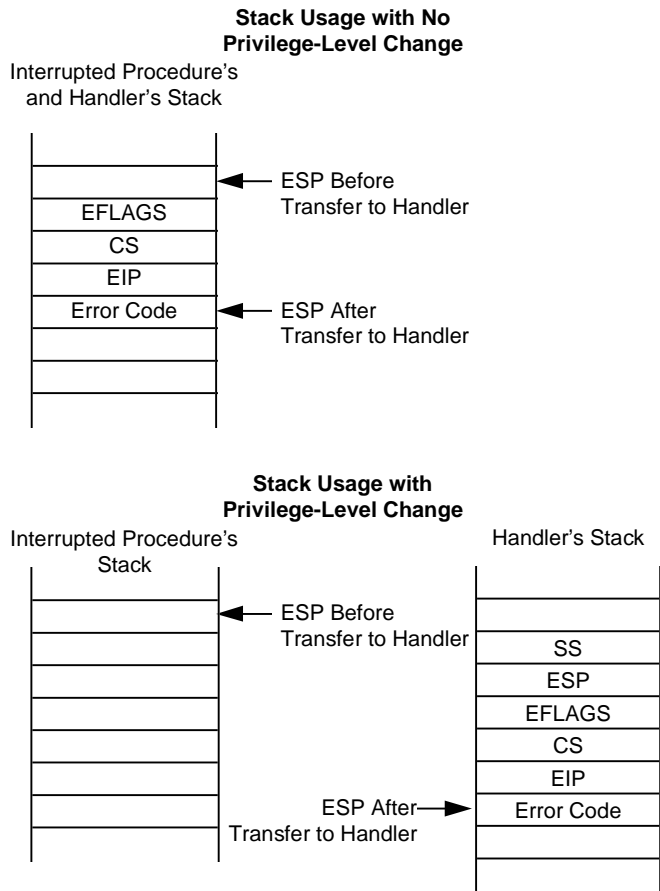
Figure 4-4. Stack Usage on Transfers to Interrupt and Exception Handling Routines
